INSPECTION REPORT

# St Johns Bridge - Photo Demo

## AI-assisted photo review

Historical OregonDOT photographs - Portland

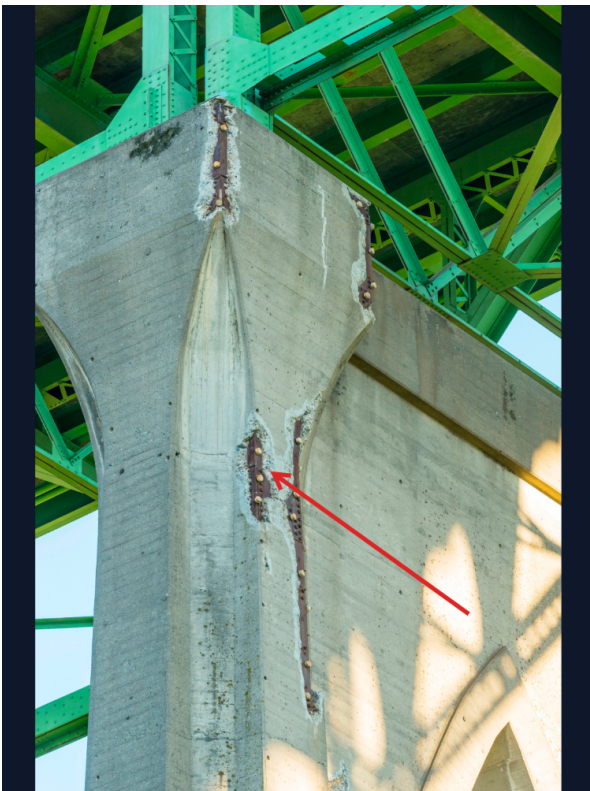
# Concrete loss at the pier edge

Medium severity · Open

Concrete is missing along the pier edge, with exposed brown-coloured reinforcement and white staining. Confirm whether this is deterioration or preparation for repair.

Next step: Check the work stage and extent on site before deciding on repairs.

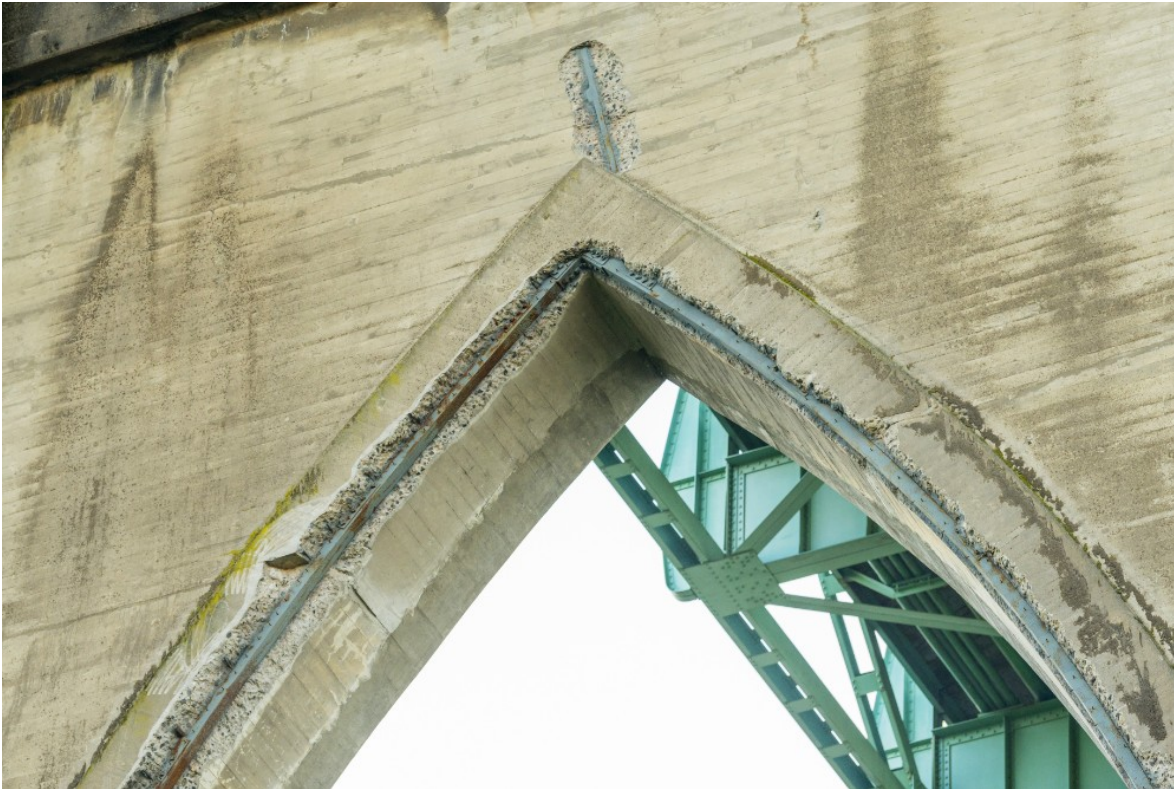
# Exposed material along the arch edge

High severity · Open

Human-reviewed note. Rough strips, local concrete loss and exposed material are visible along the arch edges. Confirm whether this records deterioration or repair preparation before specifying follow-up work. The photograph does not establish depth, cause or present condition.

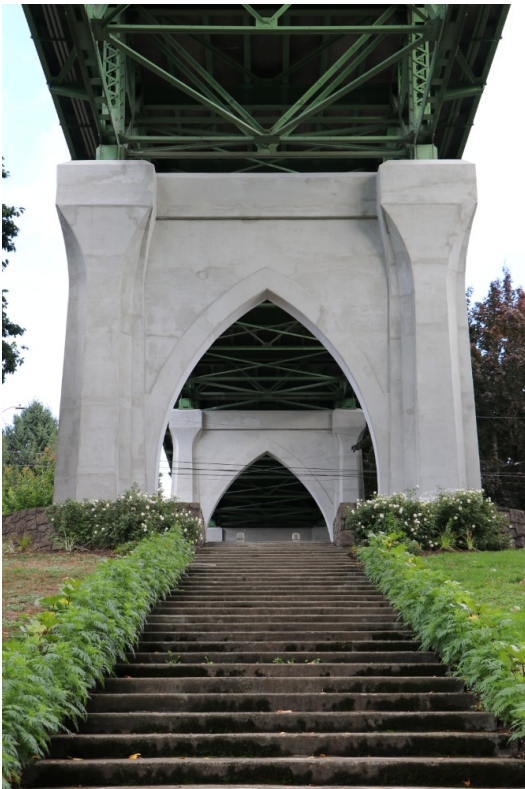
# Completed arches — overview record

Human-reviewed note. Pale arch surfaces, form lines and the adjacent stairway are visible. No clear defect can be identified at this distance. Retain as an overview and obtain closer photographs for condition assessment. This image does not certify the work or its present condition.

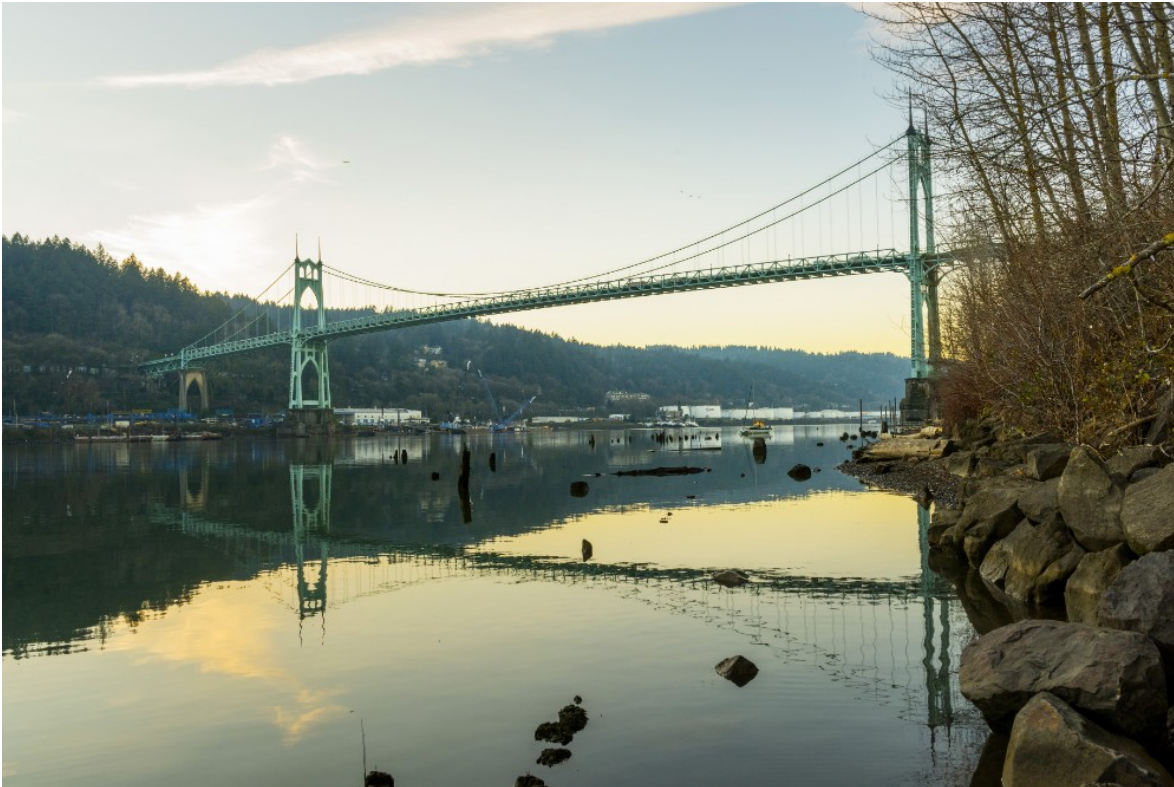
# Bridge setting — closer photos needed

Human-reviewed note. The bridge, river and shoreline are visible from a distance. Surface details are too small to assess specific defects. Record as a site overview and request close-ups of the areas requiring review. No conclusion about structural condition can be drawn from this image.
